Root Cause Analysis of the Carburized 35Cr-45Ni-Nb Tube in the Ethylene Furnace

¹Chokchai Singhatham, ²Nakaran Srisuwan, ³Rangsan Intho, ³Naphat Theerawatanachai, ³Kornnasate Pitiariyanan, ¹Krittee Eidhed

This paper focuses on the root cause analysis of cracking phenomenon of radiant tube which used in the ethylene furnaces of petrochemical plants. The tube furnace used 35Cr-45Ni-Nb alloy. The internal temperature and pressure of tube were in range of 800-900°C and 3.2 bar, respectively. The surface temperature of tube in the range 1000 - 1100°C. From the visual inspection by the Werner Caliper and Coordinate Measuring Machine (CMM), it was found that the tube dimension and surface roundness of used tube are larger than a new tube. The used tube becomes magnetized which was affected by the carburization phenomenon. The SEM micrograph of the used tube shows a large amount of area fraction of precipitated complex carbides such as (Cr,Mn)₂₃C₆ and SiC when compared with new tube. The EDS result shows significantly high amount of C and Si contents in the used tube than in the new tube. The HV hardness and tensile strength of the used tube are lower compared with the new tube, because

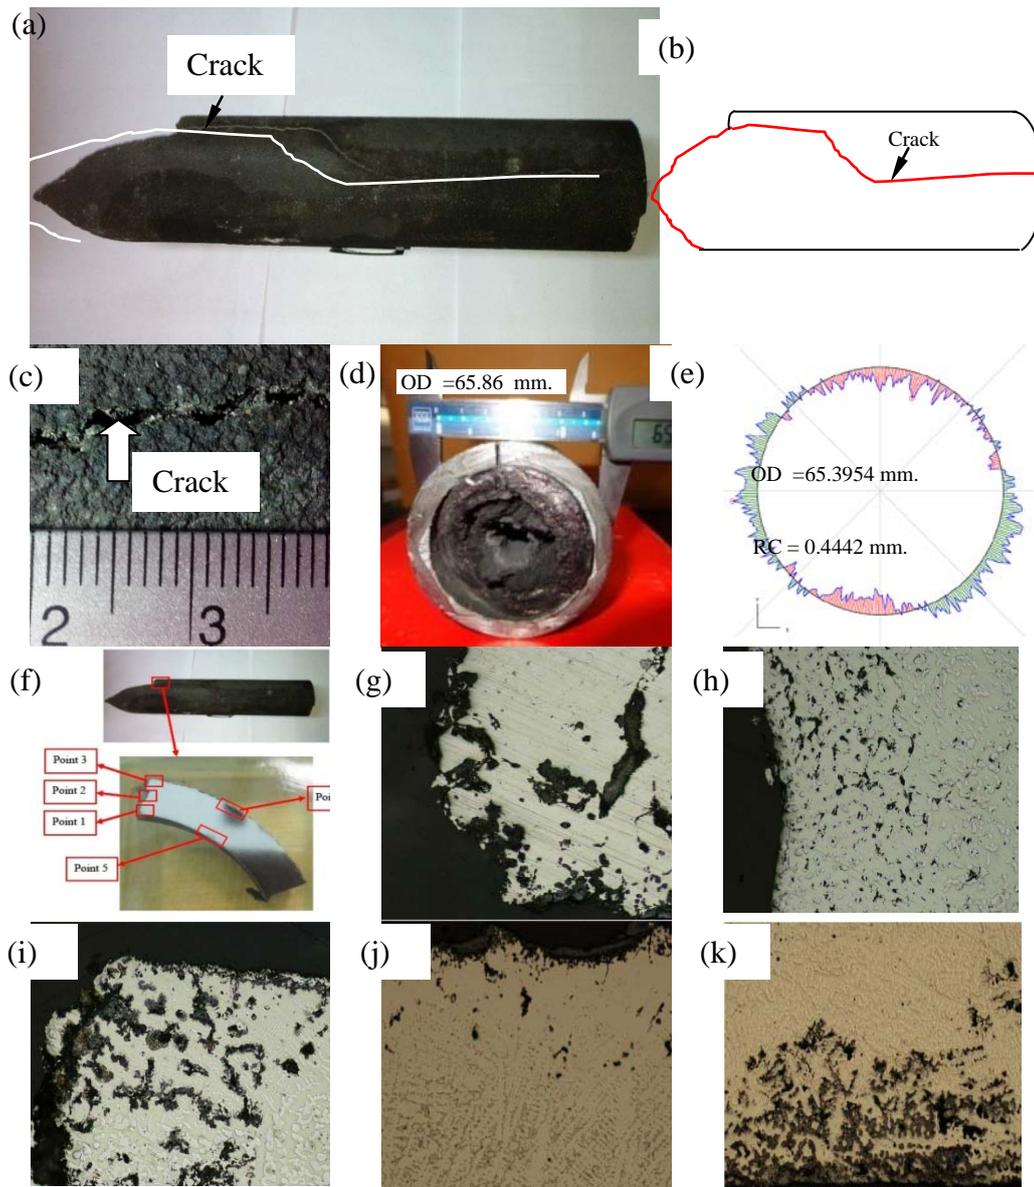
When the Fire Heater Furnace was stopped running for the maintenance, the surface temperature and internal pressure of the tube were reduced at a lower rate (equivalent ambient). The heated tube which was once enlarged would be decreased in size and volume. Some tubes, which have coke associated, cannot be decreased in to the original size. Therefore, the tube rupture was occurred. The

Fig. 2: Investigation of crack and microstructure on the used tube (a) cracking line,(b)2D sketch,(c) Surface tube crack,(d)measuring OD of tube,(e) Roundness circle(RC),(f) Profile of point checks, (g) Point 1:10x,(h) Point 2:10x,(i) Point 3:10x,(j) Point 4:5xand (k) Point 5:5x.

Form the visual examination test results, it is founded that a crack on the surface and subsurface of the used tube can be seen. The micro-crack by optical microscope (OM) has length of 1.5 mm. measured from the surface. There is coke precipitates in the tube greater than the new tube (Figure 5). It is because of the packed carbon (coke) inside the inner

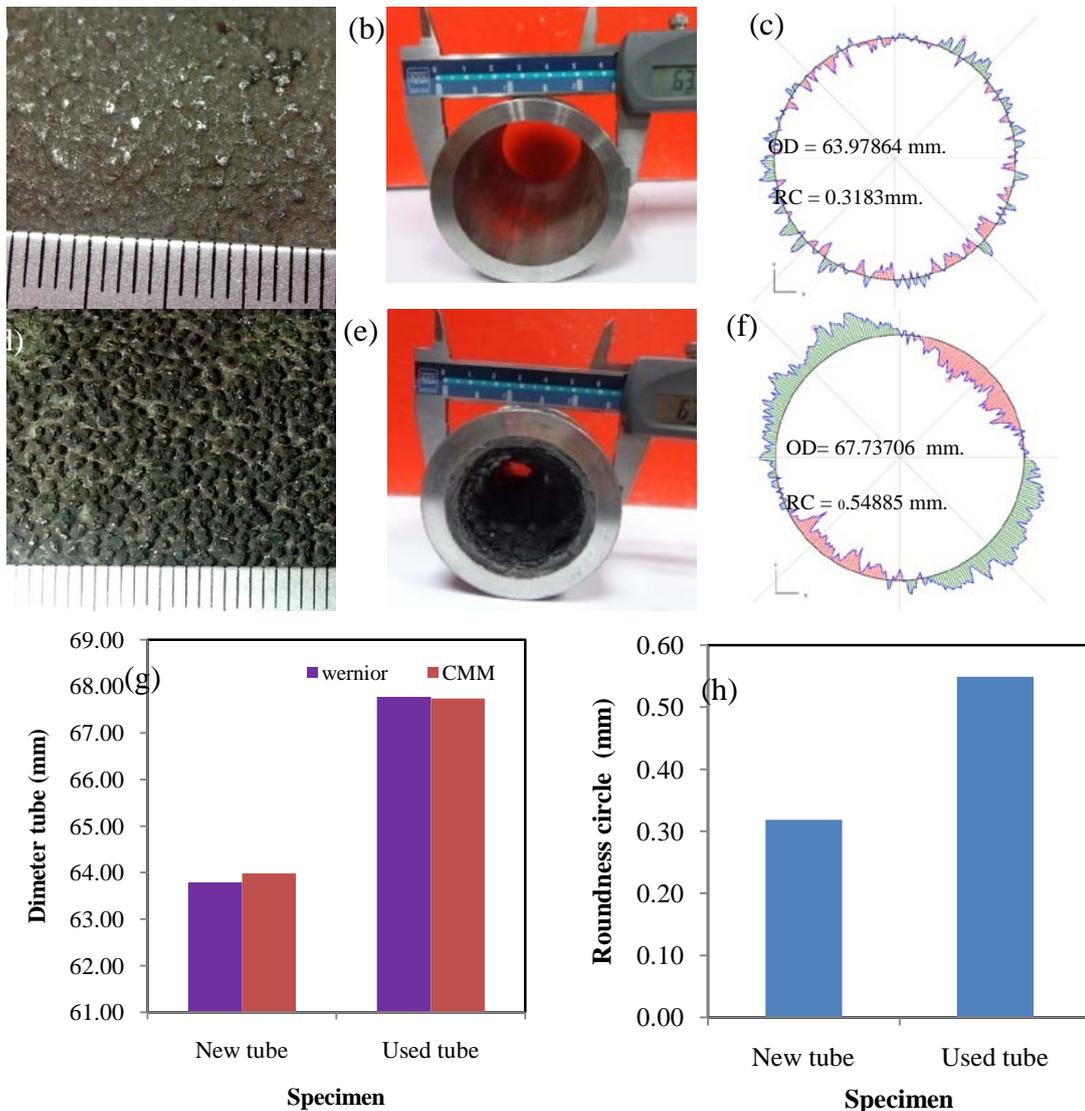
1) The used tube has a rougher surface than the new tube as shown in Figure 5a&5d, respectively. There are some black cubes scattered on the outer surface, and coke precipitates inside the tube.

2) Outside diameter(OD) of used tube is larger than the new tube when measured by Werner and CMM as shown in Figure 5(b-c) and Figure 5(e-f), respectively

3) Roundness circle (RC) of used tube is larger than a new tube when measured by CMM as shown in Figure 5(c) and 5(f).

Fig. 5: Visual inspection of tube (a,b,c)Surface, OD and Roundness circle(RC) of the new tube, respectively (d,e,f) Surface,OD, Roundness circle(RC) of the used tube, respectively(g) OD measured by wernior and CMM and (h) RC measured by CMM machine.

It is because the strength and hardness is decreased when compared with the new tube. The ultimate strength and yield stresses seem to be decreased. In other words, the used tube has lost the plasticity and elasticity at the inner layer of tube. Therefore, cracking is taken place because of a large amount of packed carbon in the tube. It cannot be shrunk to the same original condition while it is cooling down. Moreover, the shrinkage of tube in different quadrant causes different stress on each quadrant (Figure 5(f)).

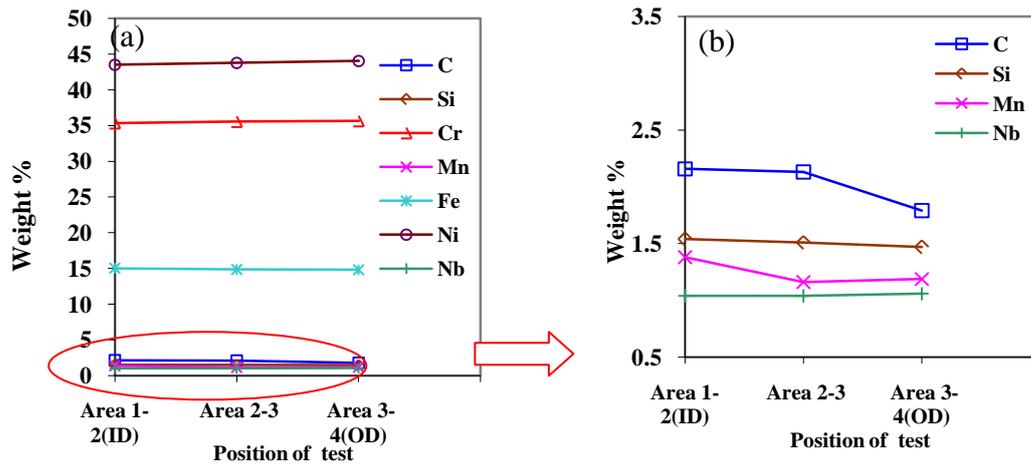
The EDS mapping is used to define the distribution of element in the new tube and used tube of the 35Cr-45Ni-Nb alloy. The result shows that the amount of carbon is found approximately 1.7 % with uniform distribution in all area of microstructure of the new tube as shown in Figure 6.In the used tube, there is high amount of carbon in area 1-2 than area 2-3 and area 3-4, respectively as shown in Figure 8.

The amount of carbon in the new tube and the used tube is different; because carbon in the used tube is diffused and covered all over the metal as a result of the amount of soot-covered is sufficient for gas atom to highly penetrate through the tube.

Fig. 8: EDS chemical analysis of used tube (a) All element and (b) Focusing On C, Si, Mn and Nb.

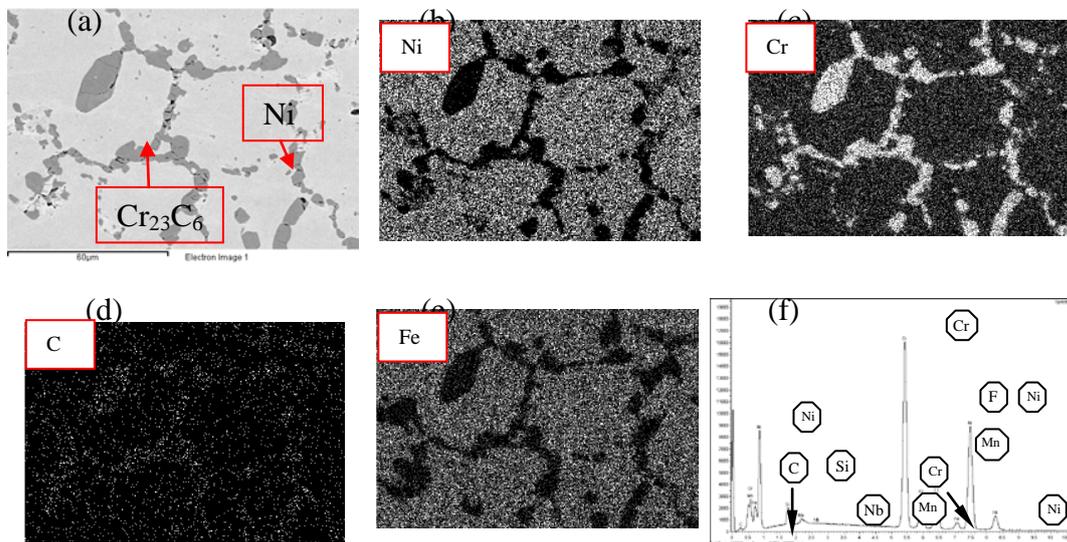
As seen in the used tube (Figure 9(a))the SEM image which is analyzed by EDS, it is found that:

a) Light gray phase is similar to the new tube.

b) Dark gray phase is probable to be an element of complex carbide such as $Cr_{23}C_6$ and mixed silicon carbide (SiC).

c) White phase which is probable to be an element of Si and can be combined with C to be precipitated as silicon carbide (SiC).

Fig. 9: EDS mapping analysis of used tube (a) SEM image (b) Ni (c) Cr (d) C (e) Fe and (f) Spectrums for each element.

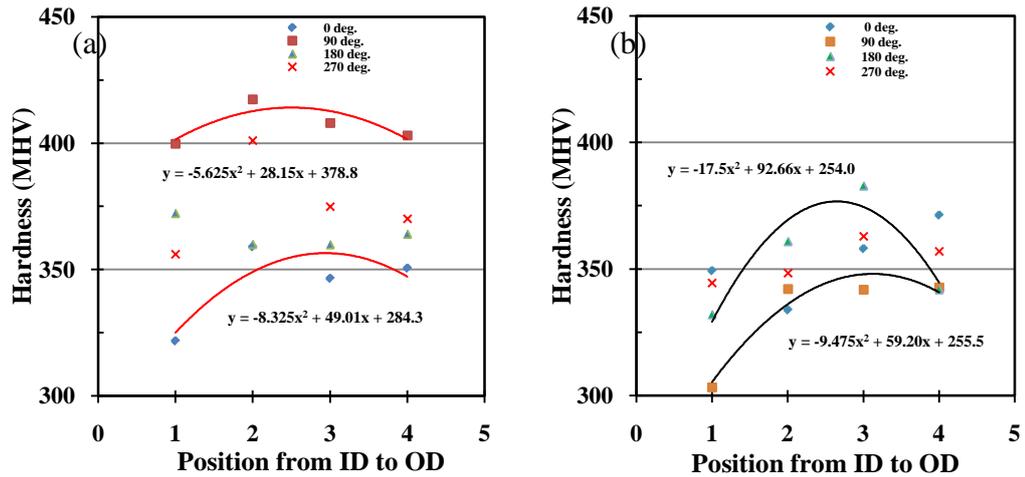
Figure 10 was shown the results of the new tube and the used tube by measuring from the outer layer to the inner layer of tube.

The value of hardness of the used tube is lower than the new tube because the thermal from service affected the internal energy change as explained below:

Fig. 10: MHV hardness (a) new tube and (b) used tube

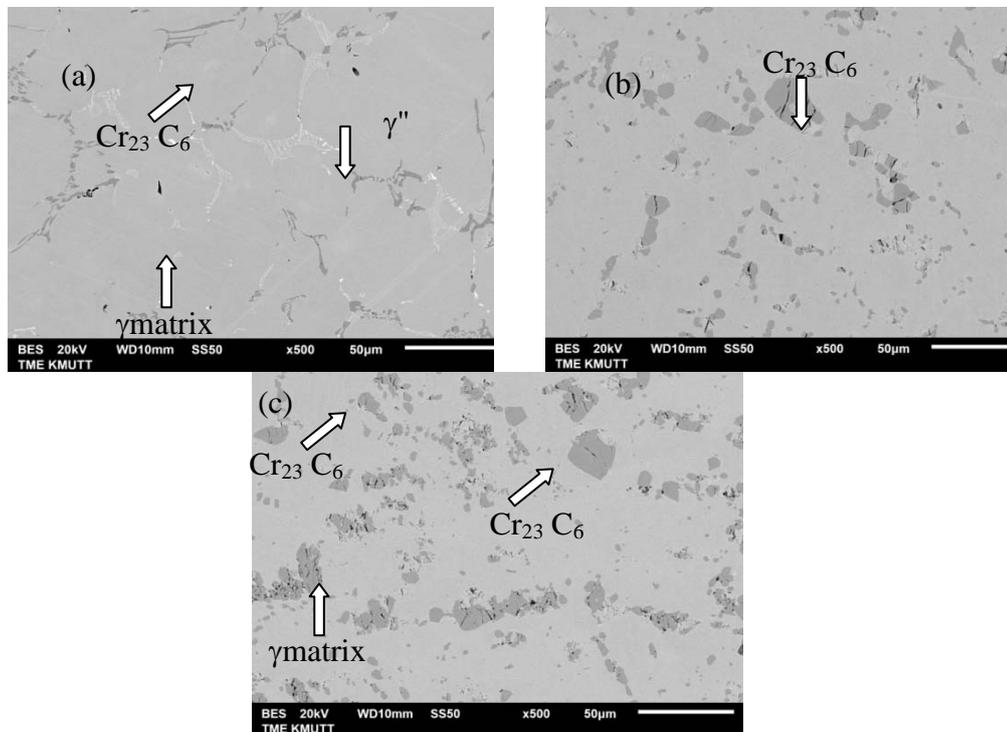
a) Chemical energy caused $\gamma'(\text{Ni}_3\text{Nb})$ to be decomposed into matrix and the grain boundary was destroyed because the inter metallic compound Cr_{23}C_6 was produced as shown in Figure 11(a).

b) Strain energy at high temperature caused the grain boundary(GB) to move easily and combine together to form a larger grain. Thus, the activation energy is combined with strain energy in the crystal structure and it reduced the interface energy at grain boundaries. Meanwhile, there is a combination of carbide in the applicable temperature for producing Cr_{23}C_6 as shown in Figure 11(b).

Fig. 11: SEM images of new tube and used tube taken from different position
(a) External surface of New tube (b) External surface of used tube and
(c) Internal surface of used tube.

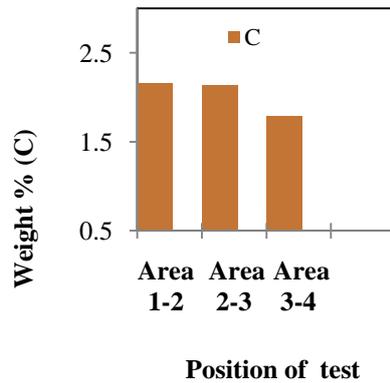
MHV of the used tube has been increased to maximum and after that it is decreased because there is a chemical compound of hydrocarbon (C_2H_4) in the tube. It is arisen from incomplete combustion and the environmental condition whose temperature and pressure can produce the new element. After that, the diffusion of carbon in the form of coke penetrated through the material (see Figure 12). Its reasons might be explained as follows:

Fig. 12: Concentration of carbon in the used tube in different areas.

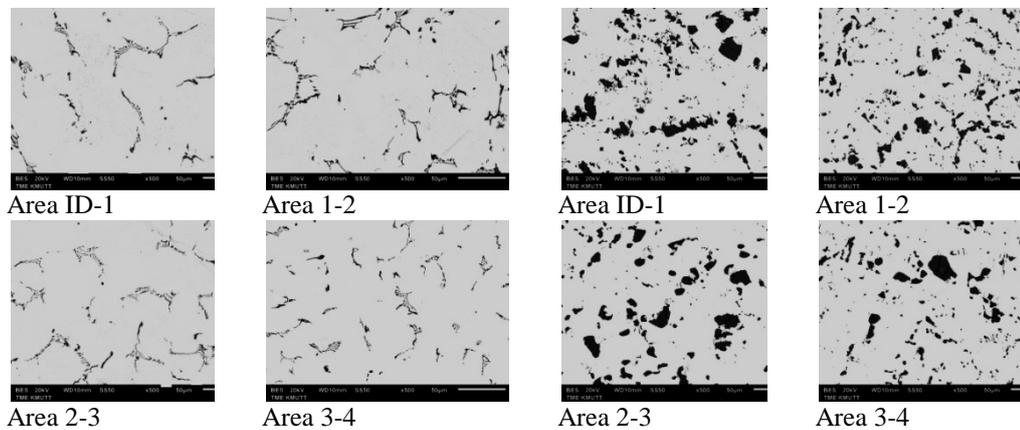
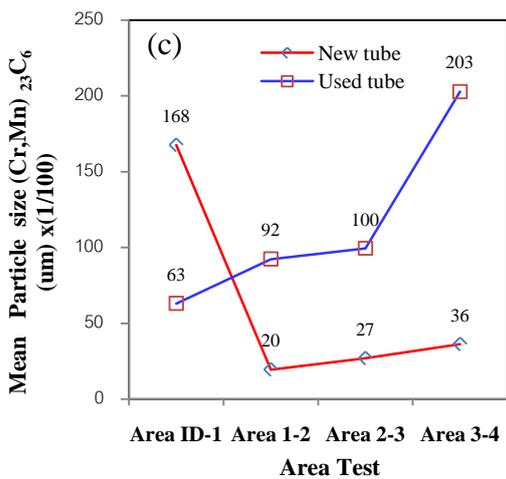
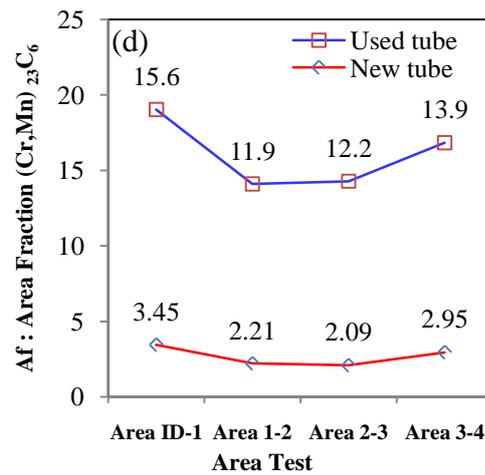
a) Particle coarsening of new tube and used tube can be seen from the microstructure in Figure 13(a) and (b), respectively. Moreover, the mean particle size (Figure 13(c)), it was founded that the coarsening grain growth in the area ID-1 more than area 3-4 measured by using the MSQ software. There is effected of service temperature of the fire heating furnace included hot spot and carburization phenomenon.

b) Degree of carburizing in tube (at cross sectional area) causes the area fraction of $Cr_{23}C_6$ and Si C), area 1-2 smaller than area 3-4 (Figure

13(d)) and the number of inter metallic compound inside the tube (1,533 particles) is greater than

outside (261 particles) measured by using the MSQ software.

Fig. 13: The new tube and used tube were checked the area fraction and particle size of $(Cr,Mn)_{23}C_6$ (a) (b) Particle size of new tube and used tube(c) Mean particle size and (d) Area fraction.

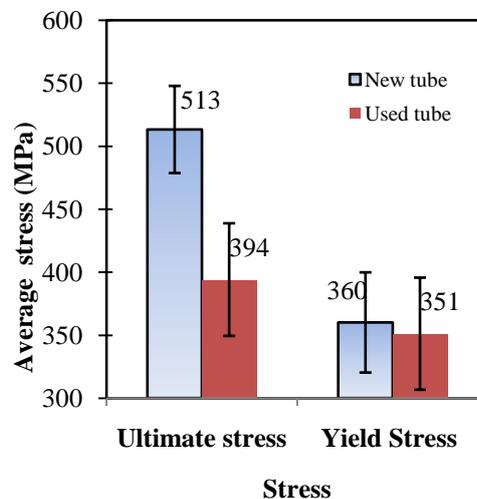
The ultimate stress and yield stress of new tube was 513MPa and 360 MPa, respectively. The results showed that the new tube had higher ultimate strength and yield stress than those of the used tube, because more carbon had decreased the tensile strength of the used tube as shown in Figure 14. It conforms to the carburizing level as explained in section 3.3.1 and 3.3.2.

Fig. 14: Tensile stress of the new tube and used tube.
