Root Cause Analysis of the Carburized 35Cr-45Ni-Nb Tube in the Ethylene Furnace

¹Chokchai Singhatham, ²Nakaran Srisuwan, ³Rangsan Intho, ³Naphat Theerawatanachai, ³Kornnasate Pitiariyanan, ¹Krittee Eidhed

This paper focuses on the root cause analysis of cracking phenomenon of radiant tube which used in the ethylene furnaces of petrochemical plants. The tube furnace used 35Cr-45Ni-Nb alloy. The internal temperature and pressure of tube were in range of 800-900°C and 3.2 bar, respectively. The surface temperature of tube in the range 1000 - 1100°C. From the visual inspection by the Werner Caliper and Coordinate Measuring Machine (CMM), it was found that the tube dimension and surface roundness of used tube are larger than a new tube. The used tube becomes magnetized which was affected by the carburization phenomenon. The SEM micrograph of the used tube shows a large amount of area fraction of precipitated complex carbides such as (Cr,Mn)₂₃C₆ and SiC when compared with new tube. The EDS result shows significantly high amount of C and Si contents in the used tube than in the new tube. The HV hardness and tensile strength of the used tube are lower compared with the new tube, because

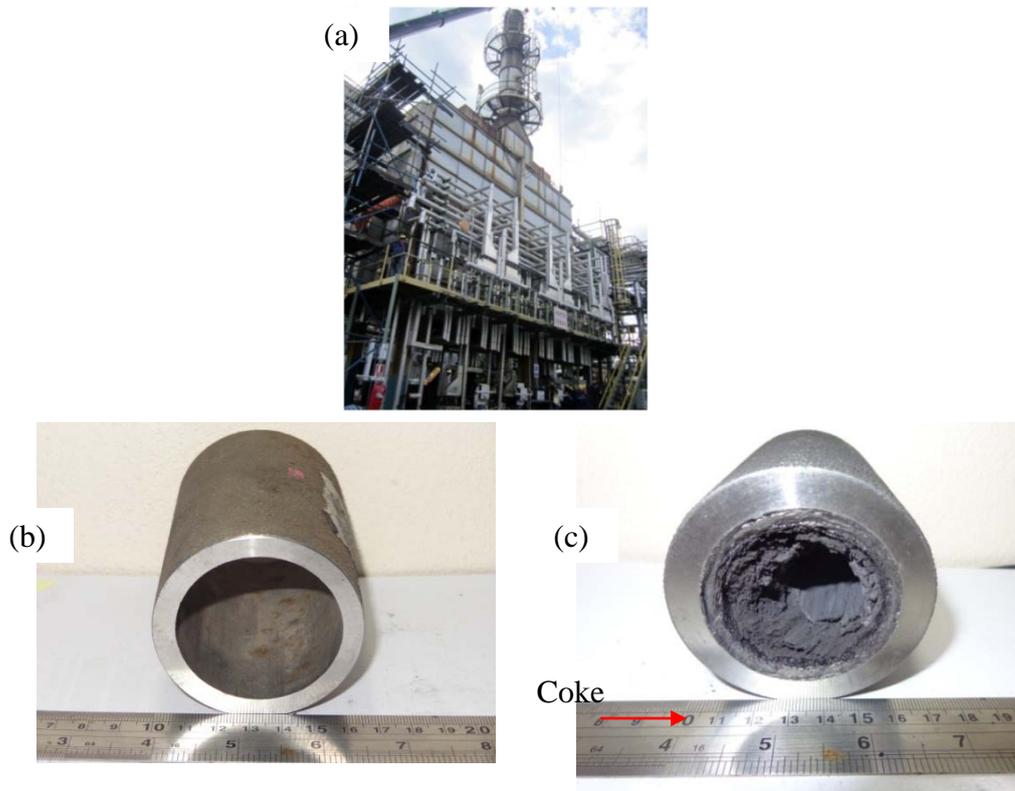
Fig. 1: The Fire Heater Furnace and tube coil of 35Cr-45Ni-Nb alloy (a) Fire heater furnace, (b) New tube and (c) Used tube with coke or soot contained

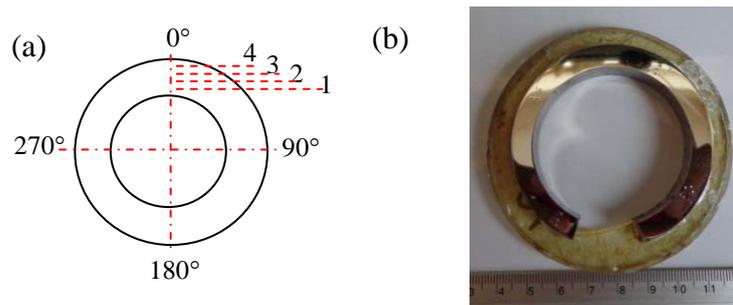
Fig. 3: Specimen Preparation for Chemical Analysis

(a) Position for scanning (b) Profile of tube of cross section.

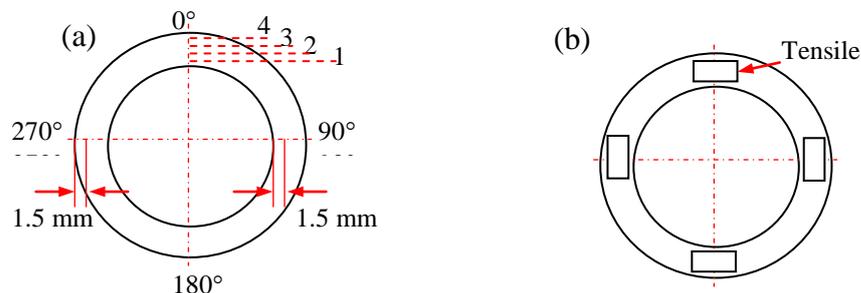
Fig. 4: Specimen preparation for mechanical testing

(a) Hardness specimen position and (b) Area Tensile specimen position.

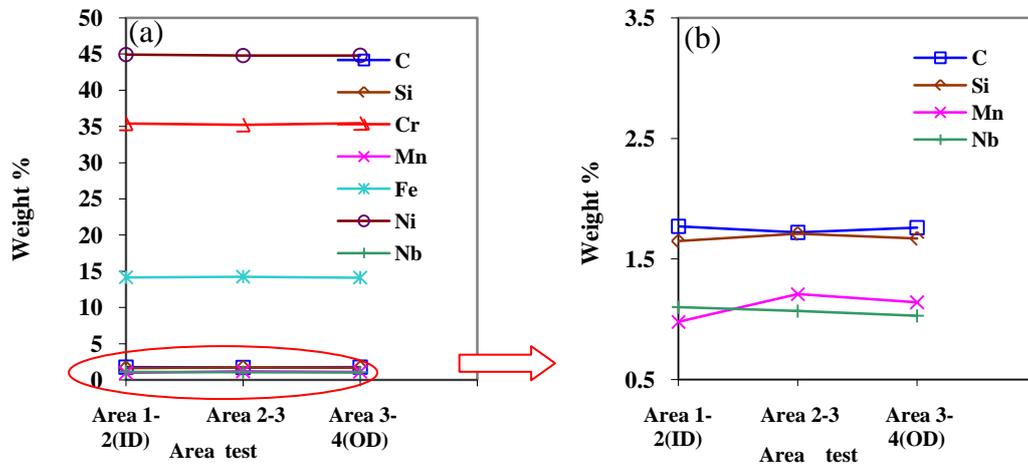
The EDS mapping is used to define the distribution of element in the new tube and used tube of the 35Cr-45Ni-Nb alloy. The result shows that the amount of carbon is found approximately 1.7 % with uniform distribution in all area of microstructure of the new tube as shown in Figure 6.In the used tube, there is high amount of carbon in area 1-2 than area 2-3 and area 3-4, respectively as shown in Figure 8.

Fig. 6: EDS chemical analysis of new tube (a) All element and (b) Focusing on C, Si, Mn and Nb.

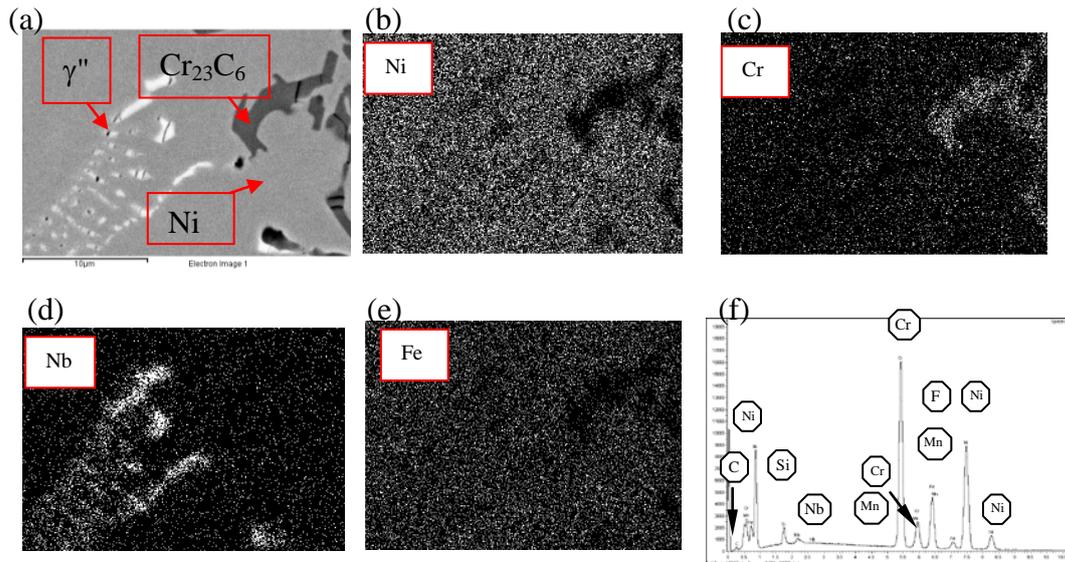
The EDS mapping is used for determining the distribution area of elements in the new tube and used tube as shown in Figure 7 and Figure 9, respectively. The result shows that there are three phases in the matrix of the new tube and used tube. The qualitative comparison can be explained as follows: As seen in the new tube (Figure 7(a))the secondary electron (SE image) which is analyzed by EDS, it is found that:

Fig. 7: EDS Mapping analysis of new tube (a) SEM image (b) Ni (c) Cr (d)Nb (e) Fe and (f) Spectrums for each element.

layer of tube had swollen during operation with high temperature and high pressure. Then carbon atom had been diffused through the matrix of inner tube. Then, it formed complex carbide such as $Cr_{23}C_6$ or SiC and other different area fractions (Figure 13(d)) to be formed in the matrix structure of inner tube. (Figure 7 and 9).
